# Manhole Inspection Summary

Manhole # S37QQ\_038MH

Insp Date: 1/30/07 1:55 PM

**Location** Address: **2435 GREENMOUNT AVE**

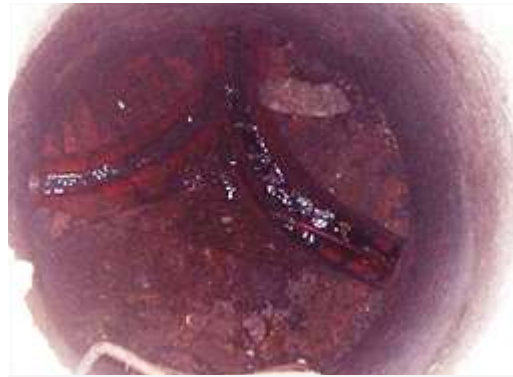
Top View

☒ **Debris** (not Condition related)

☒ **Evidence Of Surcharge**

Evidence of surcharge - Bench debris.  
Channel debris.

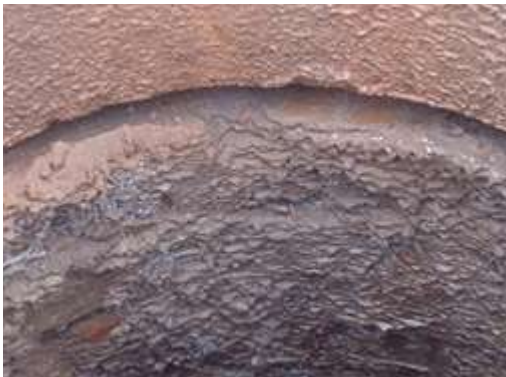
Defect

☒ **Leaks**

Condition: ☐ Sound ☐ Cracked ☐ Root Intrusion ☐ Loose Brick ☒ **Deteriorated**

Infiltration: ☐ None ☒ **Joint** ☐ Cracks ☐ Mortar ☐ Roots ☒ **Wall**

Frame leaks. Adjustment deterioration  
and infiltration.

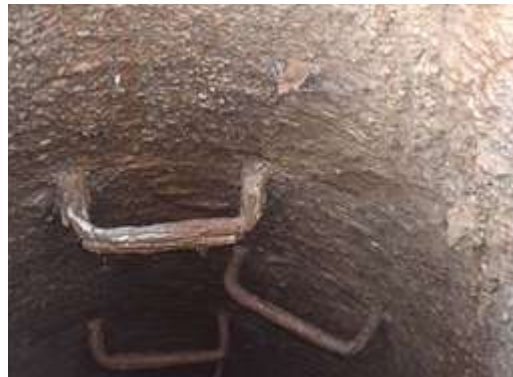
Defect

Missing: **1**

☒ **Corroded**

Corroded and missing steps.

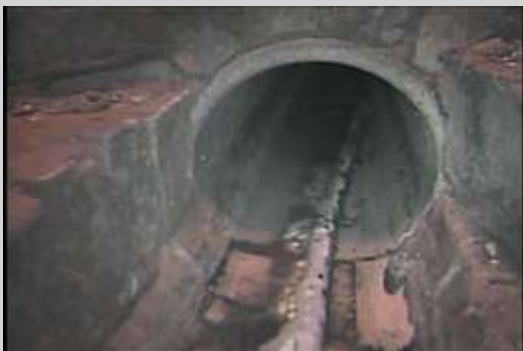
### 8 in. Circular Gravity Sewer Pipe In @ 4 O'Clock

Deposits: ☐ None ☐ Mud ☐ Sludge ☒ **Debris** ☐ Grease

Silt Depth: **0** (in.) Deposits Extent: **Light**
